MISSOURI POWER AND LIGHT DAM

AUDRAIN COUNTY, MISSOURI

MO 10065

PHASE I INSPECTION REPORT  
NATIONAL DAM SAFETY PROGRAM

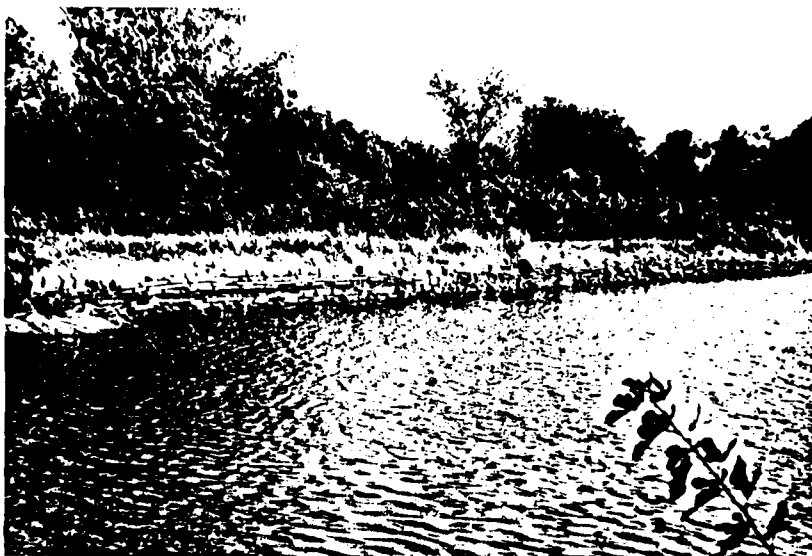
The crest of the dam is adequately protected by a heavy vegetative cover. The upstream slope of the embankment is in deteriorated condition. The wall constructed of loose blocks of used concrete and rocks is unstable in many places, appearing to be on the verge of failing into the reservoir. Cracking, indicating movement, can be seen behind the wall in several areas. Extensive rodent activity is occurring on the upstream slope and crest. Several large holes could be seen which are likely occupied by muskrats. Shells of fresh water

Photo 3 - Picture of typical section of upstream embankment slope near left side of dam.

4. Clear large trees and brush from the downstream embankment slope, and prevent future growth by frequent maintenance.
5. Make repairs, as necessary, to the upstream slope, including strengthening areas currently exhibiting instability.

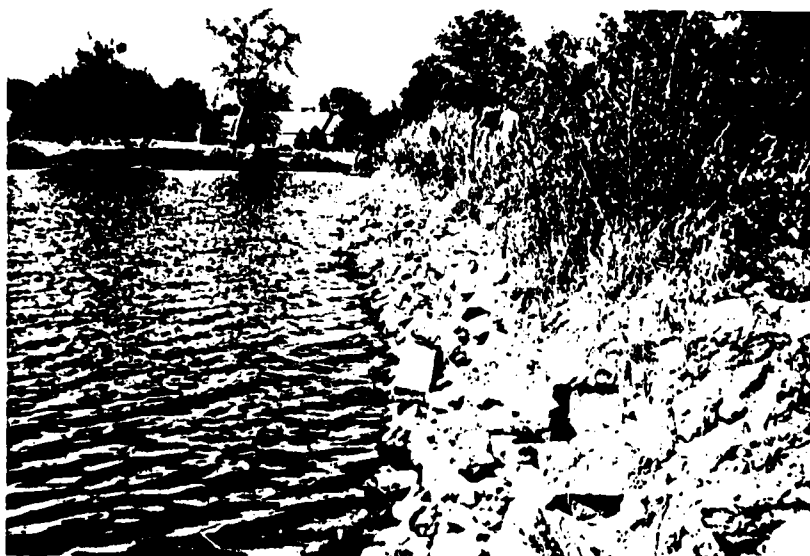
Photo 4 - Picture of upstream embankment slope taken on upstream slope near center of dam.
